#4722

WHEREAS, the Commissioner of the Department of Licenses and Inspections has declared the property located at 505 North Broom Street, parcel #2602730277 (the “Property”) to be in such condition as to constitute a public nuisance building as set forth in Wilmington City Code Section 4-27, subsections 116.1.4(a) and 116.1.5; and

To:	Ellis Blomquist	From:	M. J. Paul, PE Del. Prof. Eng. Reg. No. 9692
Company:	City of Wilmington Licenses and Inspections	Project:	505 N. Broom Street Wilmington, Delaware
Subject:	Removal of Collapsed Rear Block	Date of Site Visit:	June 21, 2019

To:	Inspector Blomquist	From:	M. J. Paul, PE Del. Prof. Eng. Reg. No. 9692
Company:	City of Wilmington Licenses and Inspections	Project:	505 N. Broom Street Wilmington, Delaware
Subject:	Condition Assessment Update	Date of Site Visit:	September 24, 2019

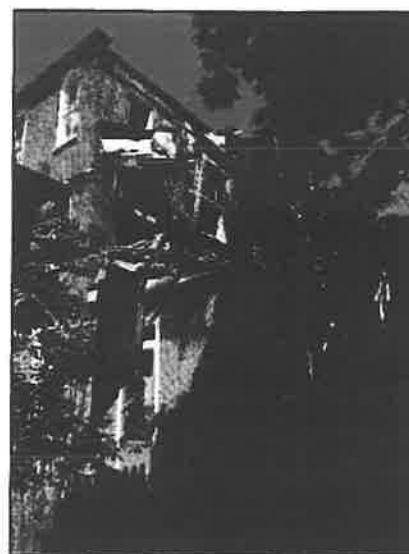
Image 1 - Rear block of 505 N Broom St

The partially collapsed rear block of the above-captioned building constitutes an immediate hazard to that property and its occupants, and it poses a nuisance if not hazard to both adjacent properties and their occupants. The rear block should be demolished immediately.

As with demolition generally, removal of the rear block must be done top-down. The partially collapsed condition reinforces this method imperative, and also argues for the engagement of a well-qualified demolition contractor with a proven record of successfully completing difficult demolition projects.

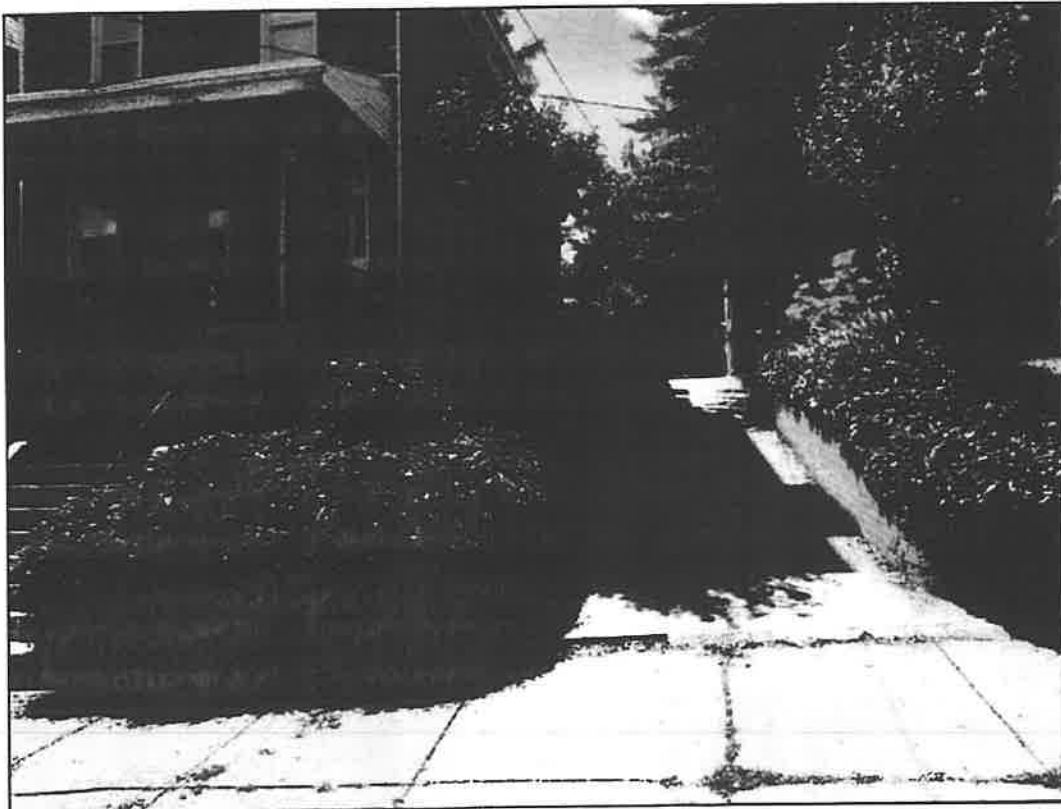
Powered equipment (including boom lifts) probably will result in the safest and quickest demolition. However, deploying and operating the equipment will not be easy and will require the use of neighboring properties. (See Images 2 through 5.)

Image 2 - Google Maps screenshot showing general site conditions

Image 3 - Back yard of 507 N Broom St along 505 rear block

Image 4 - Fence between back yards of 507 and 509 N Broom St

Image 5 - Driveway of 509 N Broom St alongside 507

Small-model equipment can be brought up the driveway of 509 N. Broom Street. Then the fence between 509 and 507 can be removed temporarily to bring the equipment into the back yard of 507. The equipment can be operated from that back yard, or the equipment can be moved into the back yard of 505 after it has been cleaned up and prepared.

After demolition debris and the equipment have been removed in reverse of the same route, the back yards, fence, and driveway must be restored.

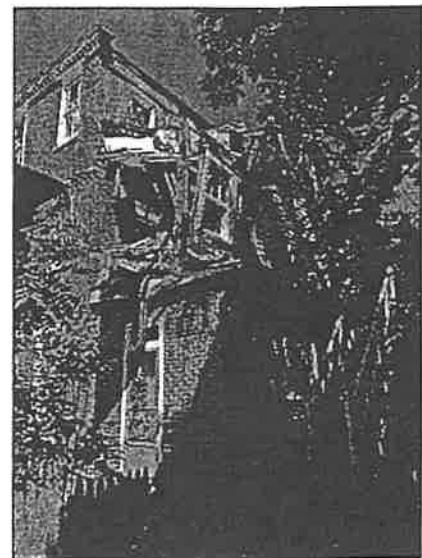
Image 1 - Rear block of 505 N Broom St

The partially collapsed rear block of the above-captioned building constitutes an immediate hazard to that property and its occupants, and it poses a nuisance if not hazard to both adjacent properties and their occupants. The rear block should be demolished immediately.

As with demolition generally, removal of the rear block must be done top-down. The partially collapsed condition reinforces this method imperative, and also argues for the engagement of a well-qualified demolition contractor with a proven record of successfully completing difficult demolition projects.

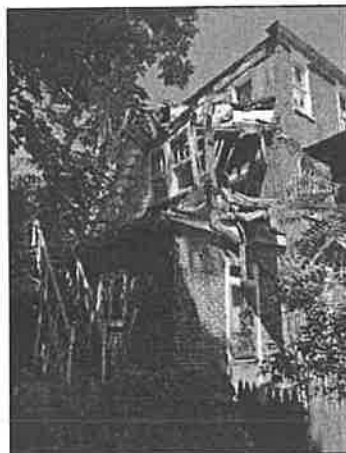
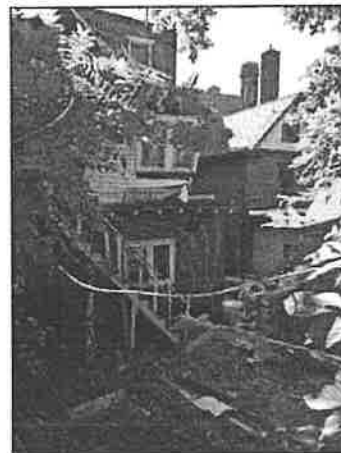
There do not appear to have been substantive changes in the condition of the partially collapsed rear block (or in the main block). It is our opinion, however, that ongoing deterioration in the partially collapsed rear block poses a possible hazard to the adjacent property at 503 N. Broom Street. It is possible that there could be sudden further collapse that results in debris entering the side yard and rear yard of 503, and perhaps lodging against the side of that building. Because of this possible hazard, we recommend that the rear block of the building be demolished immediately.

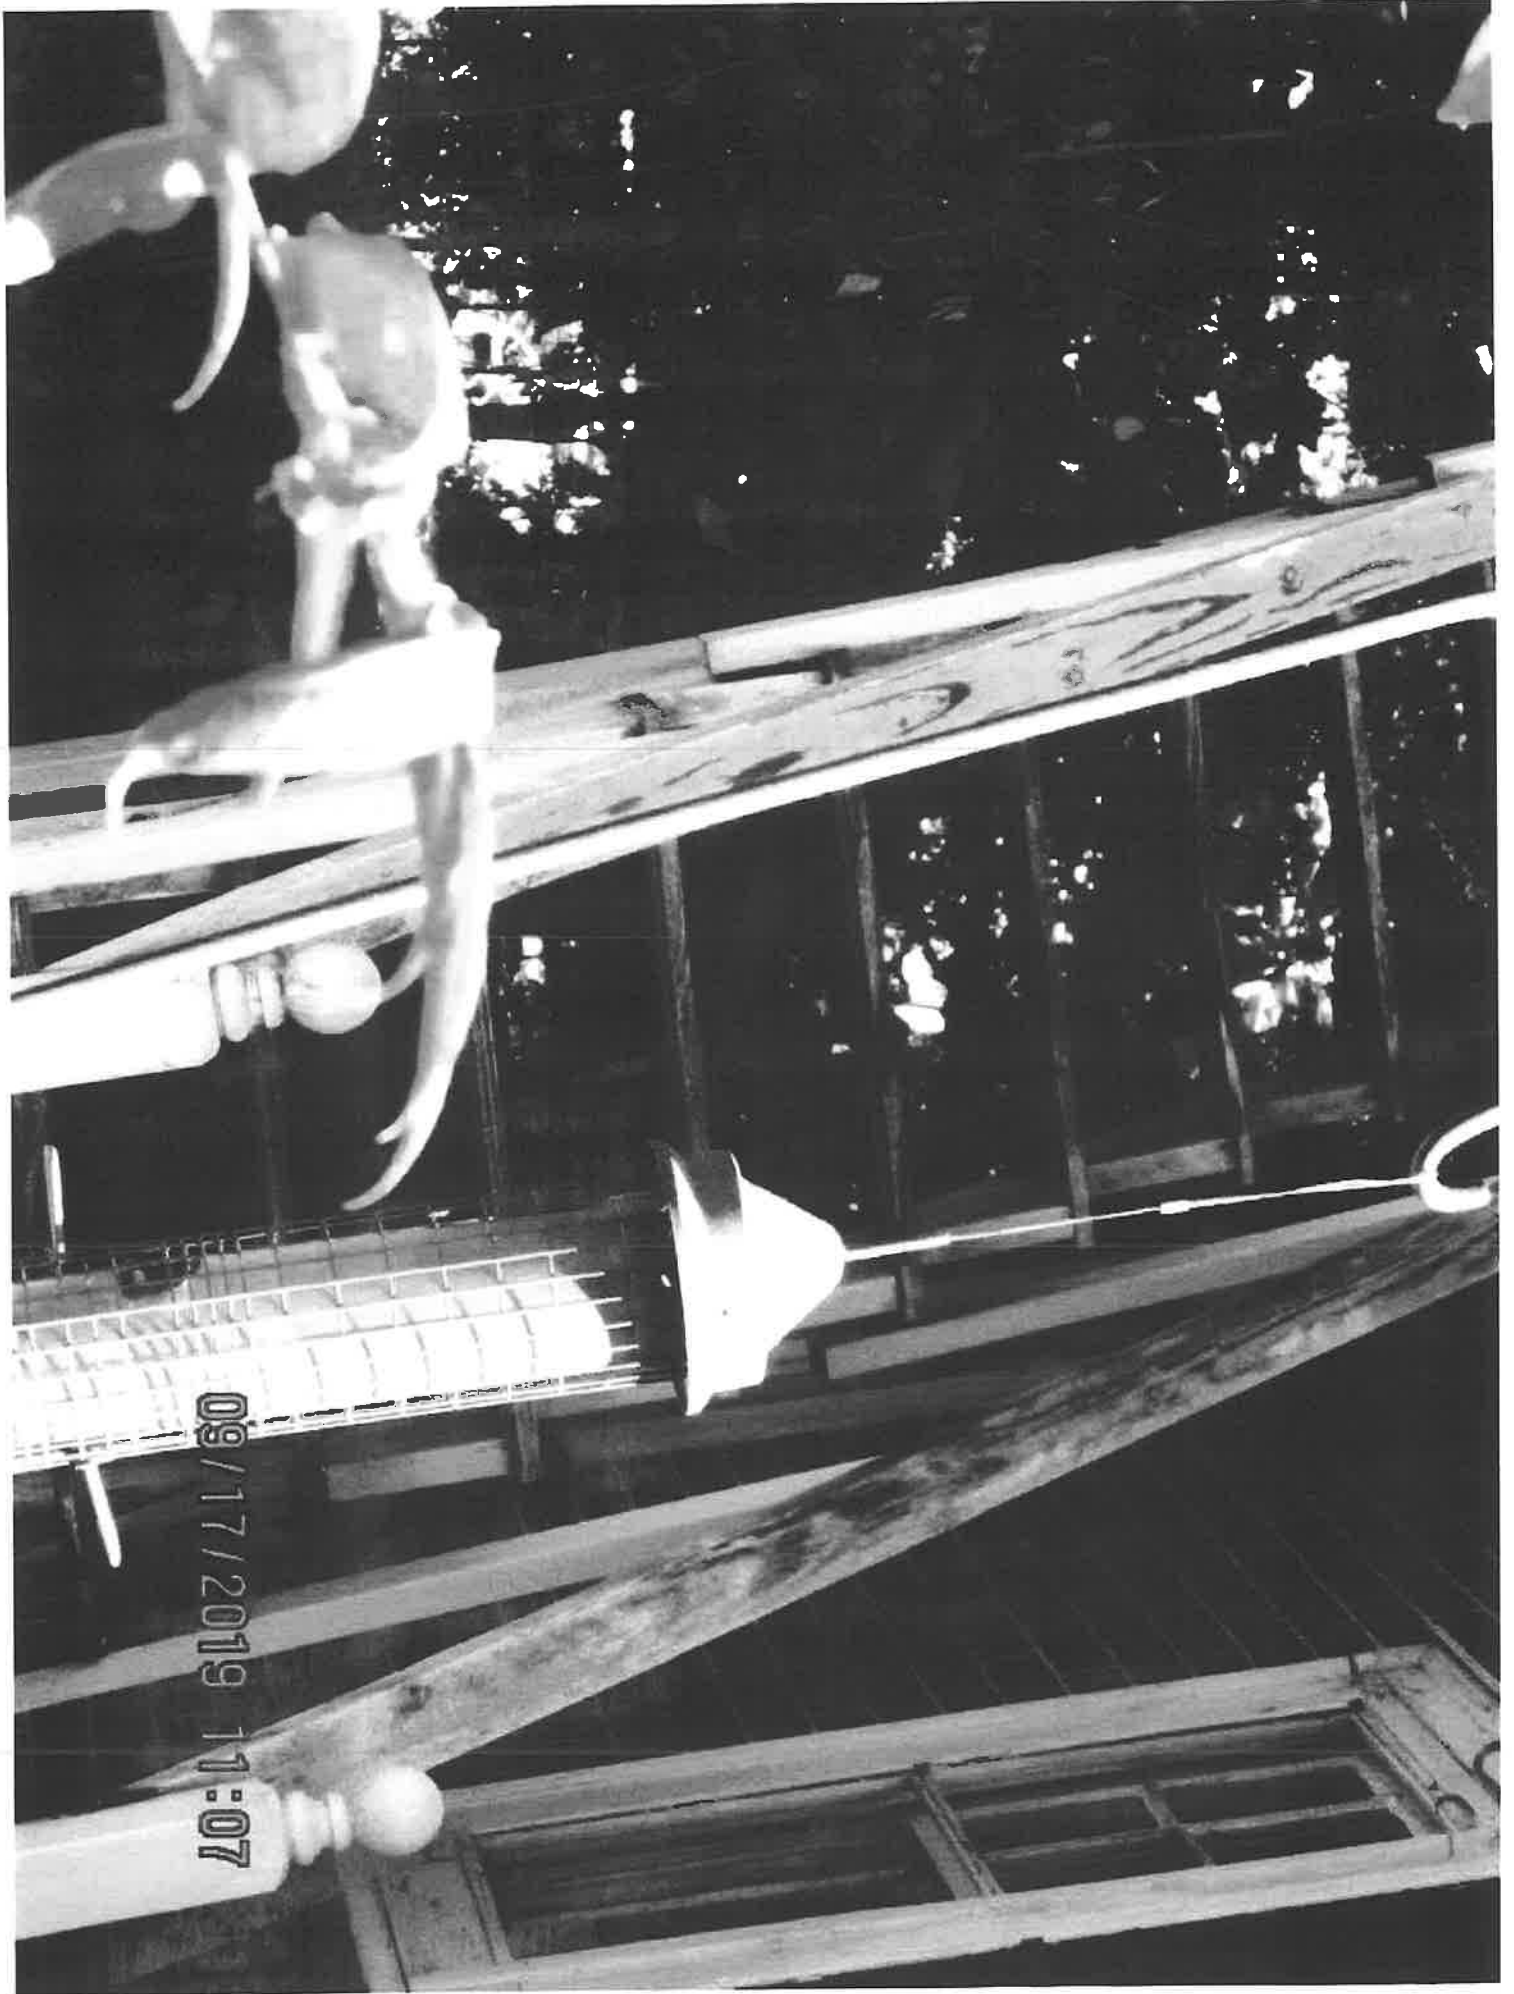
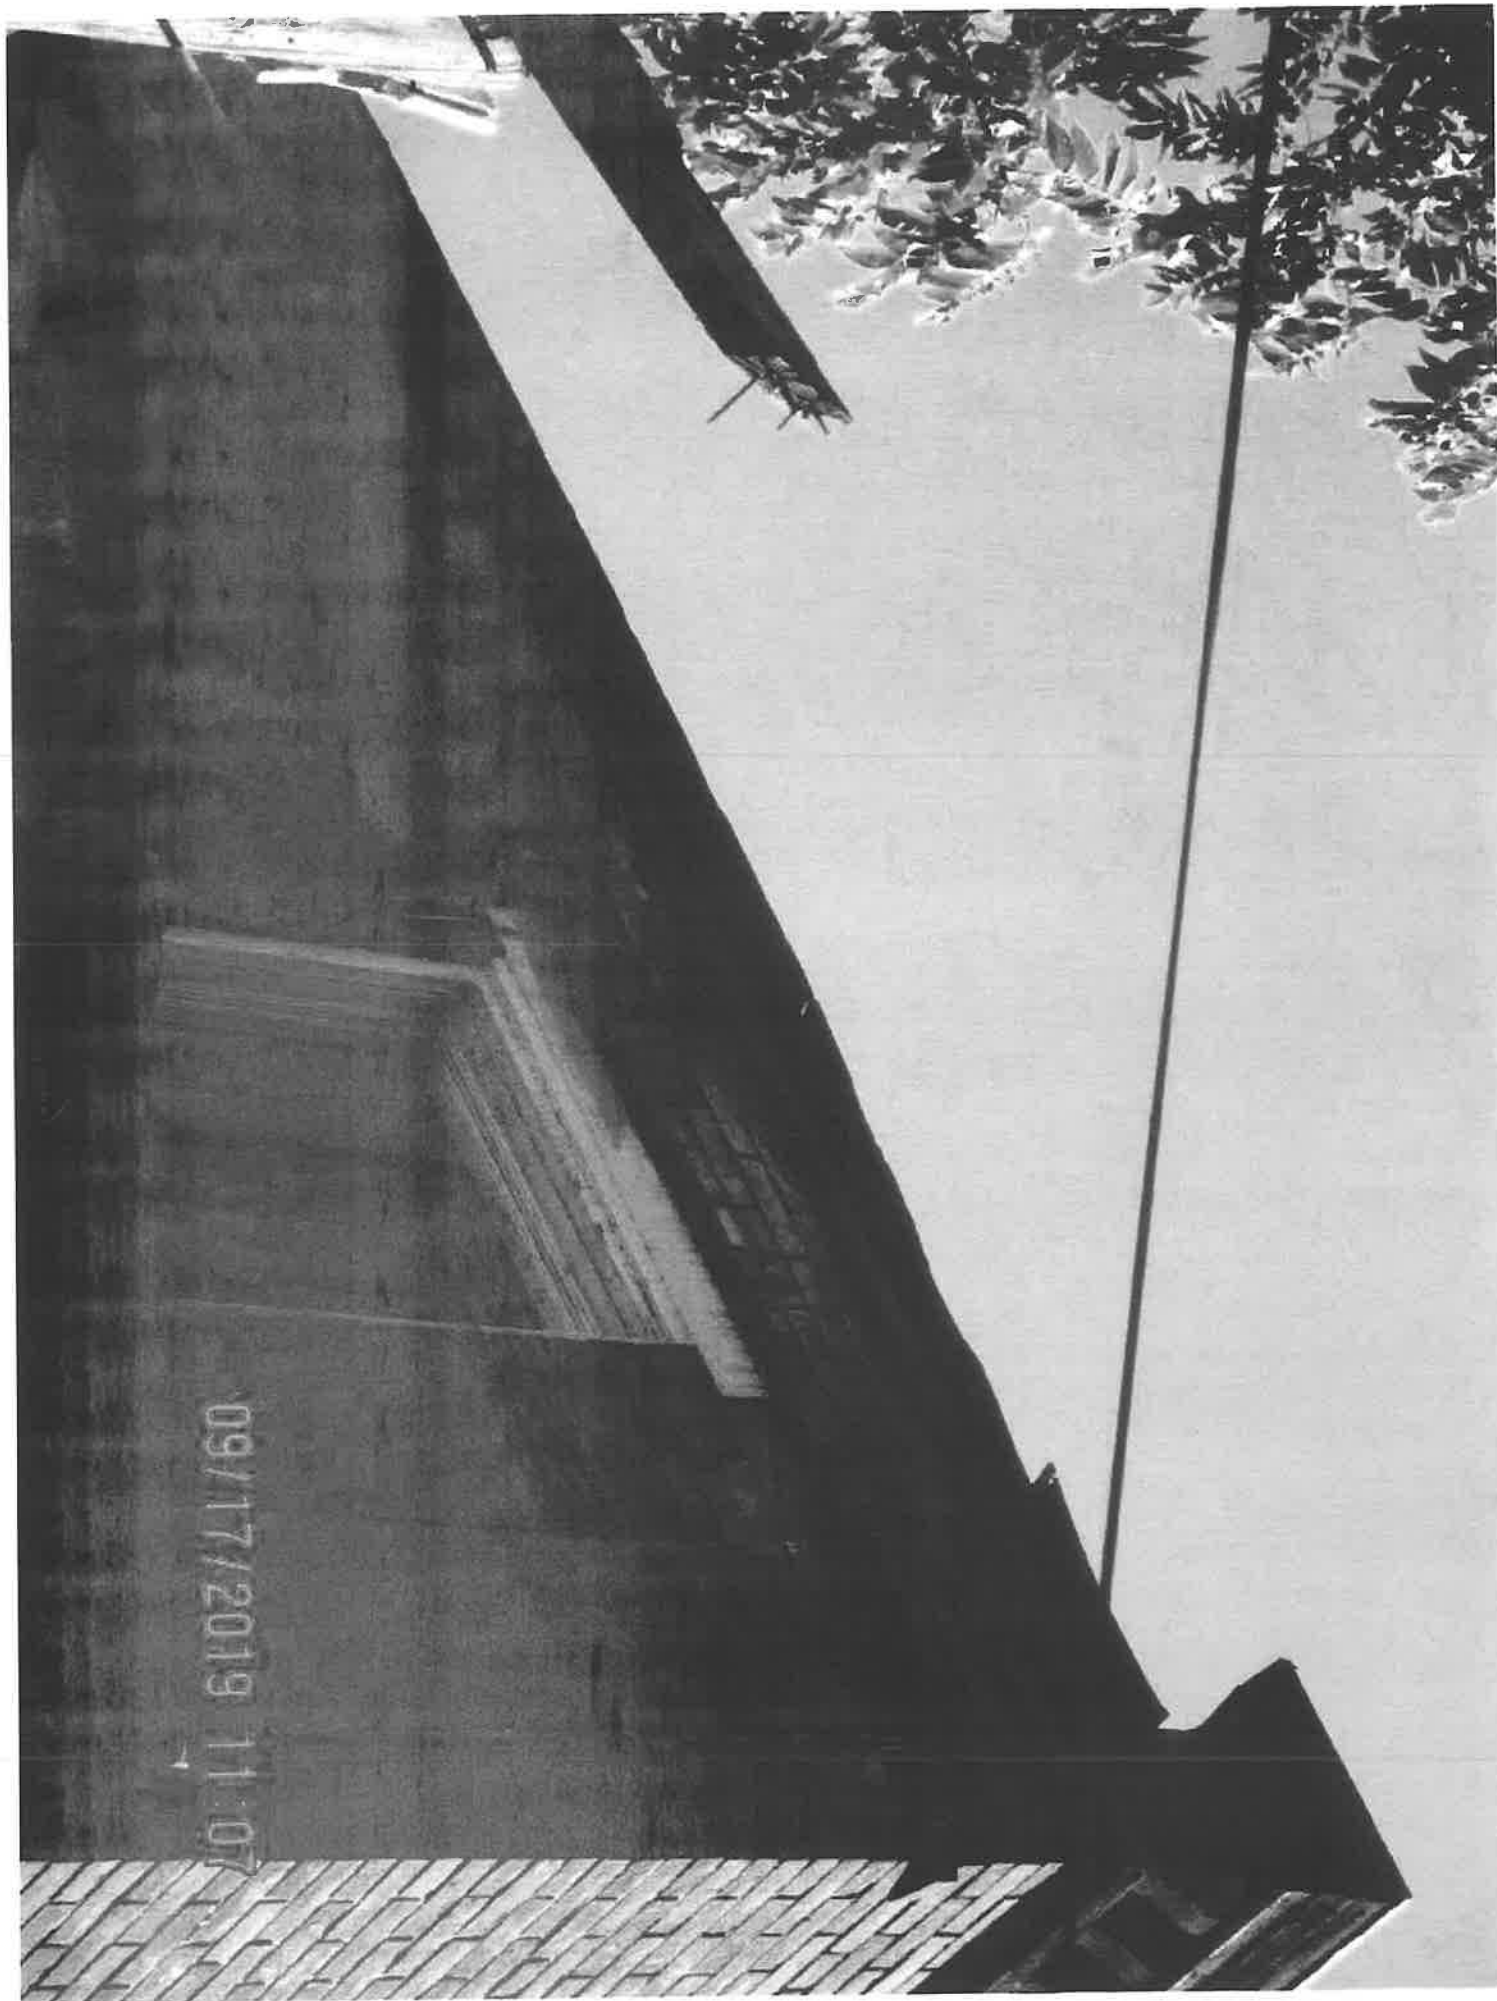
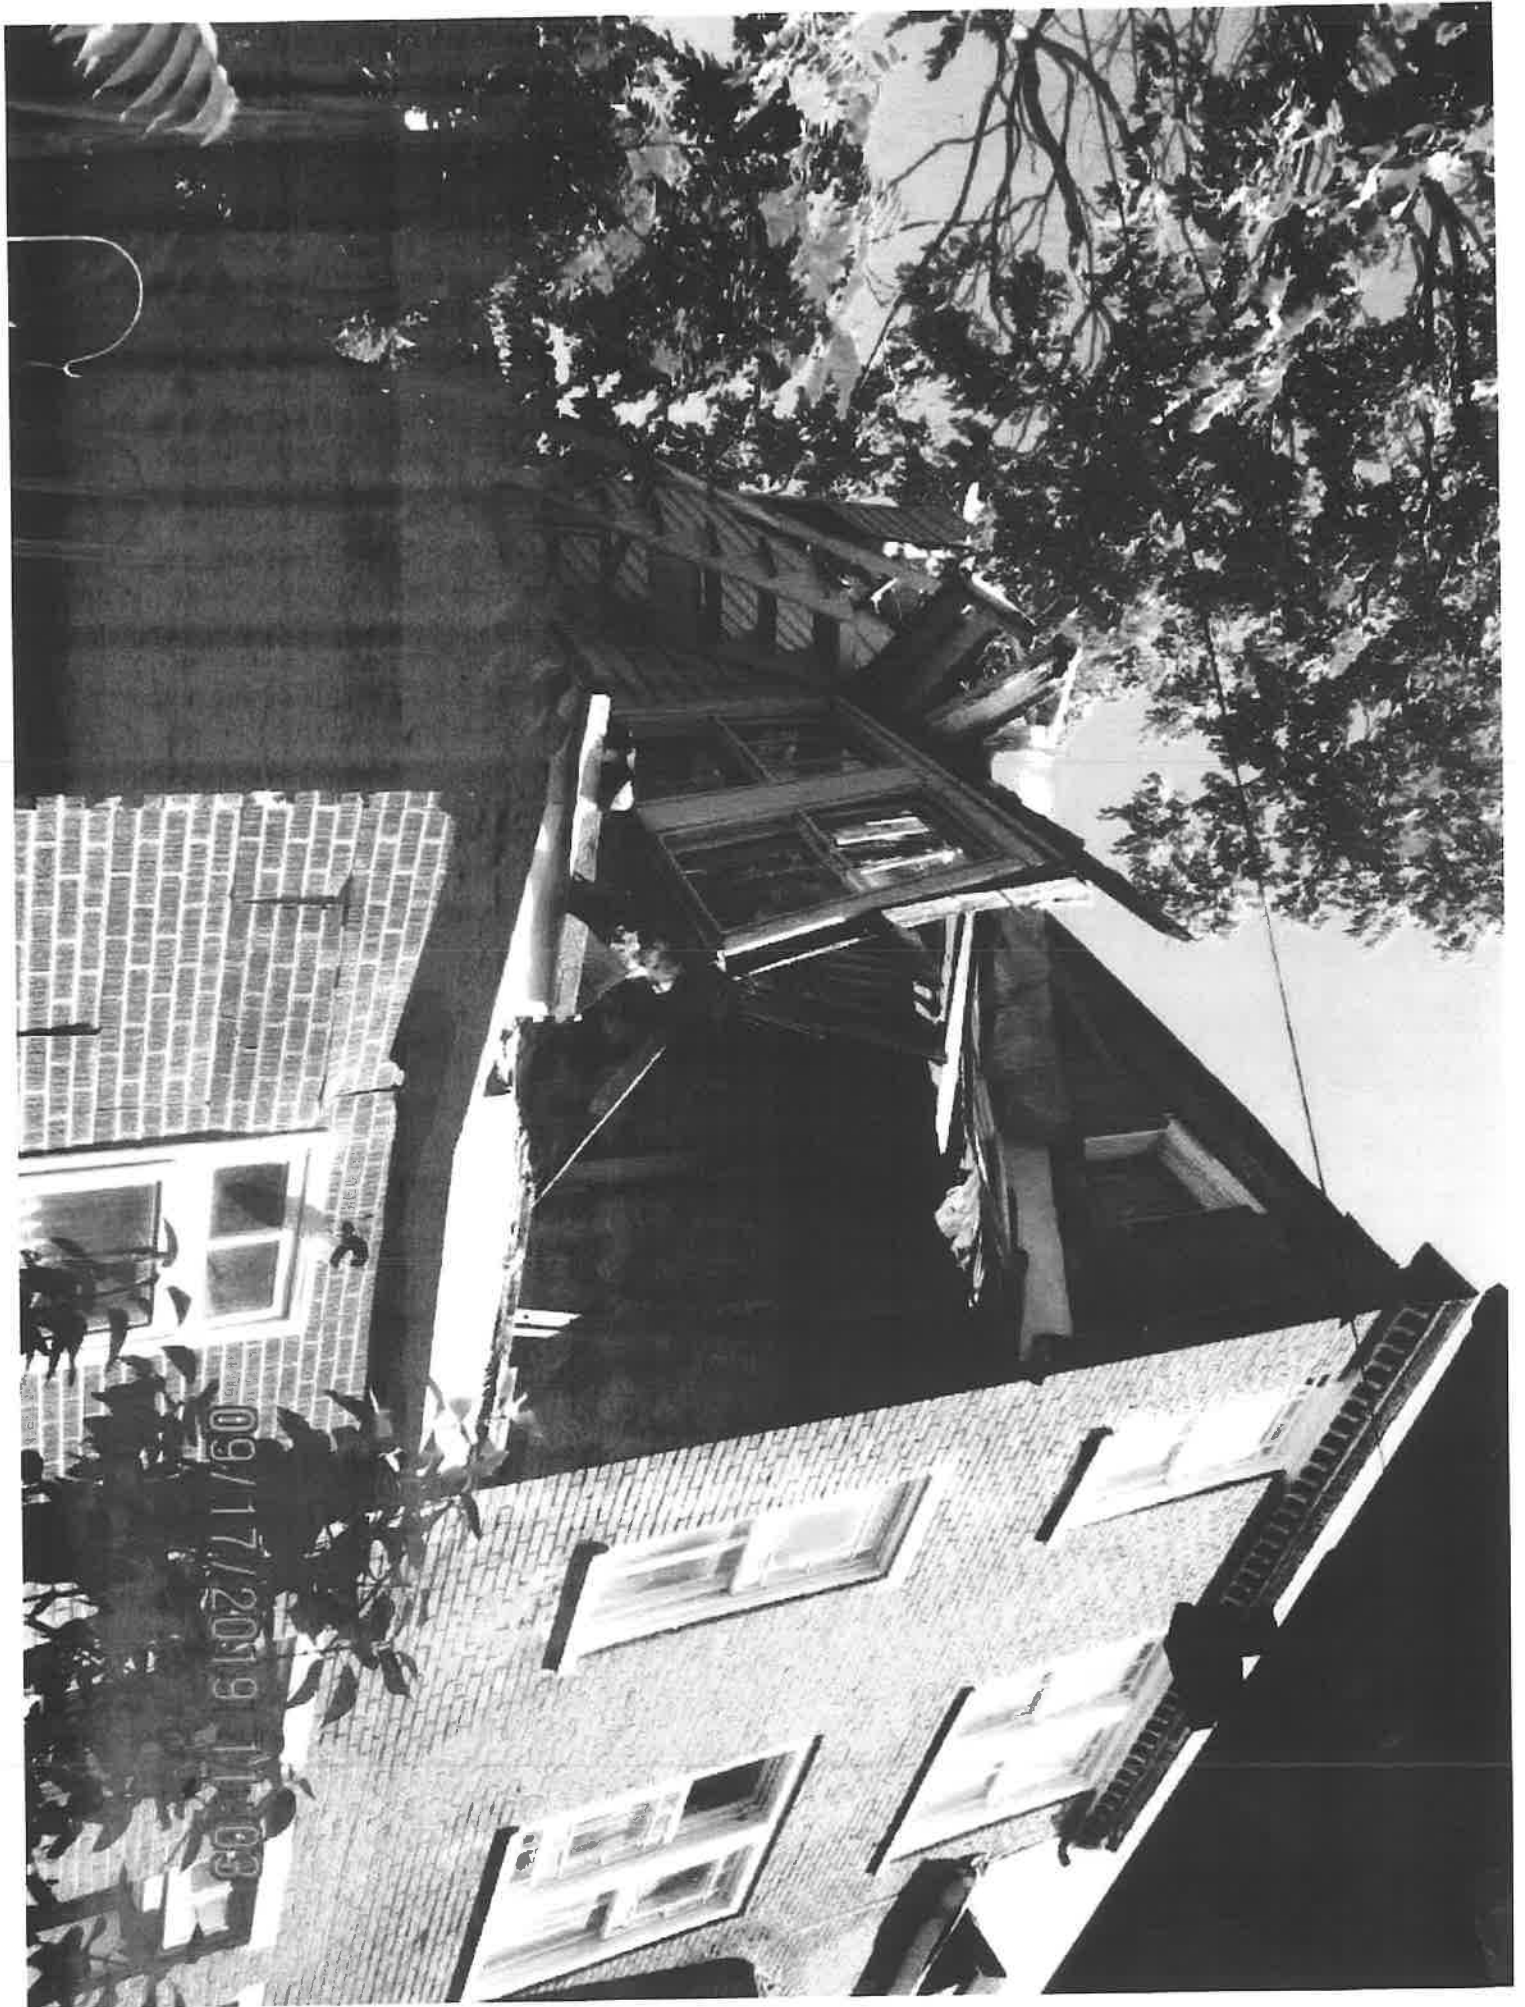
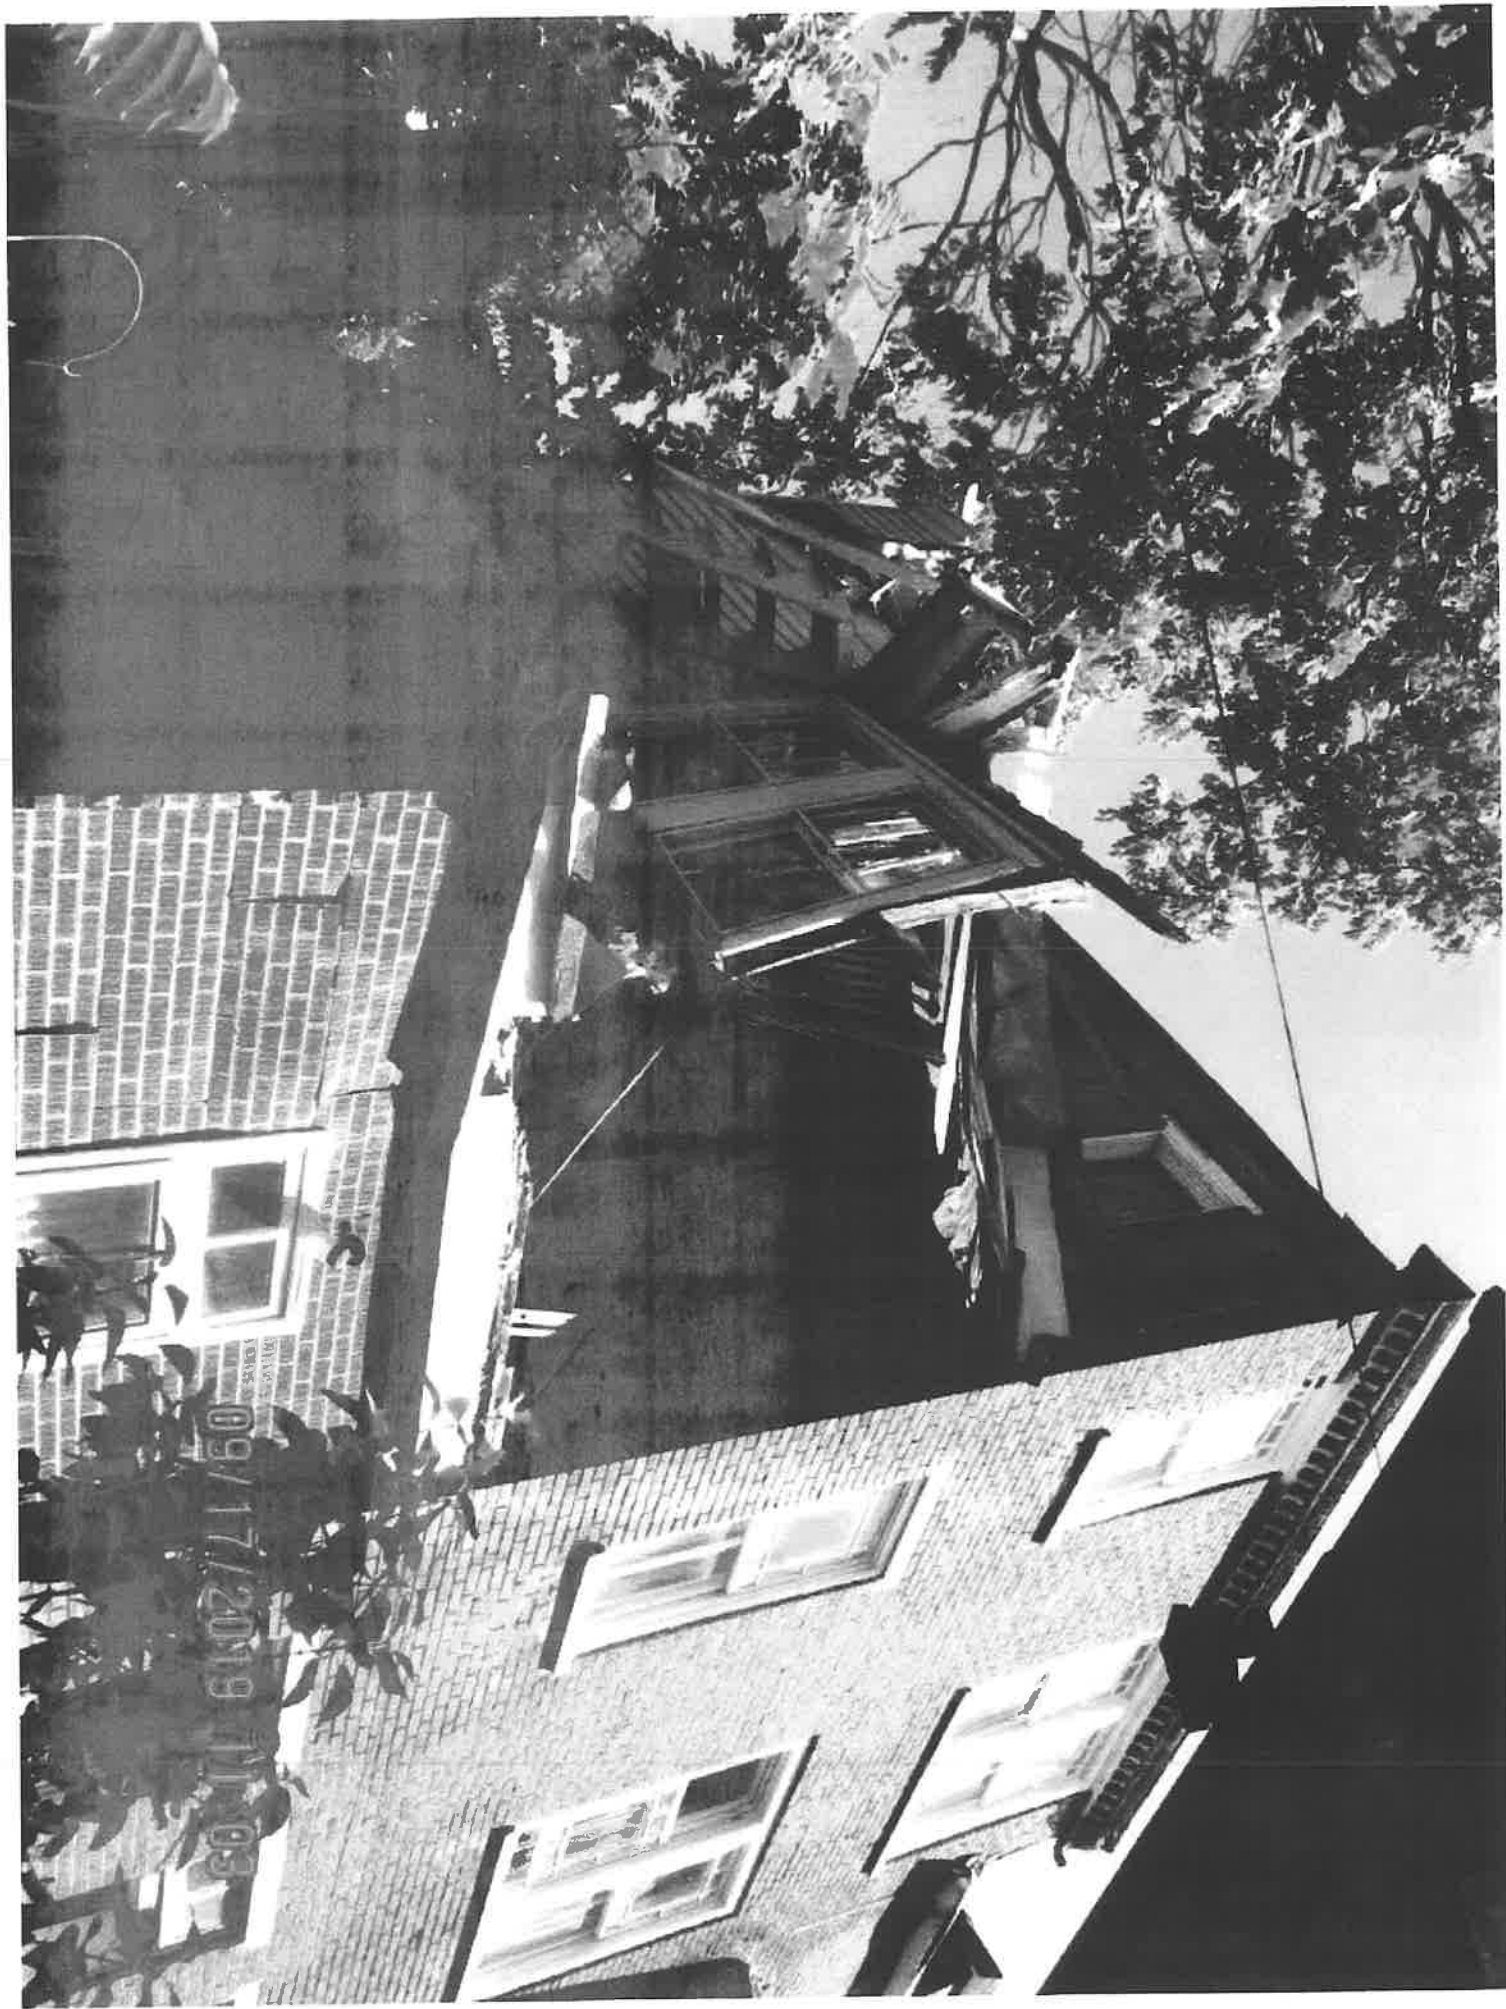
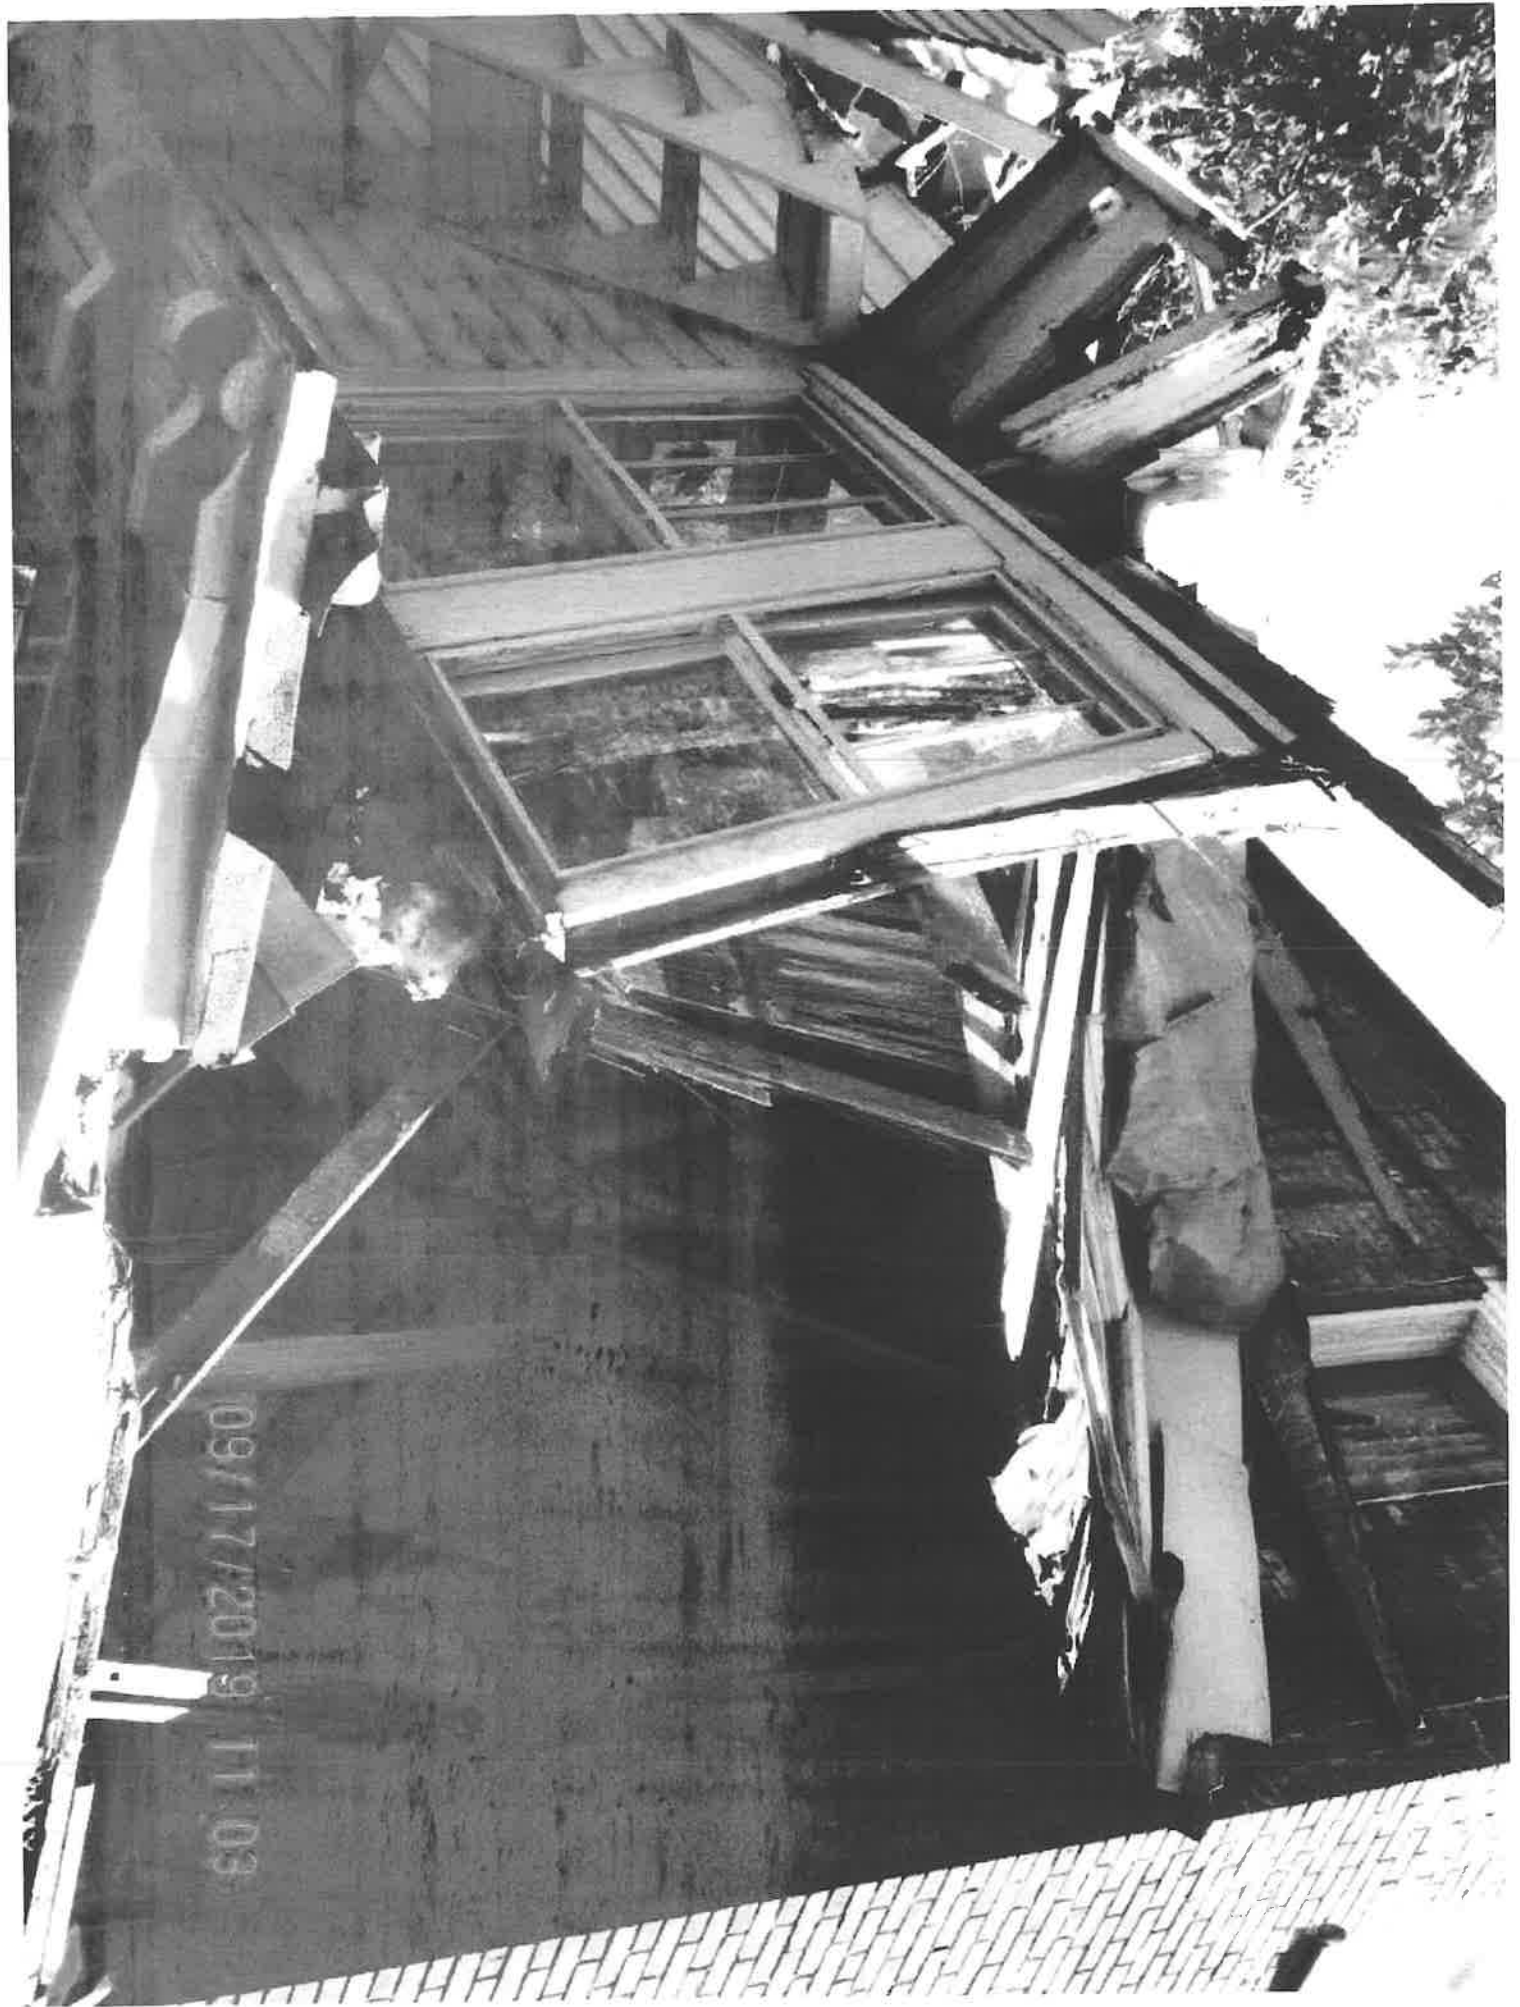
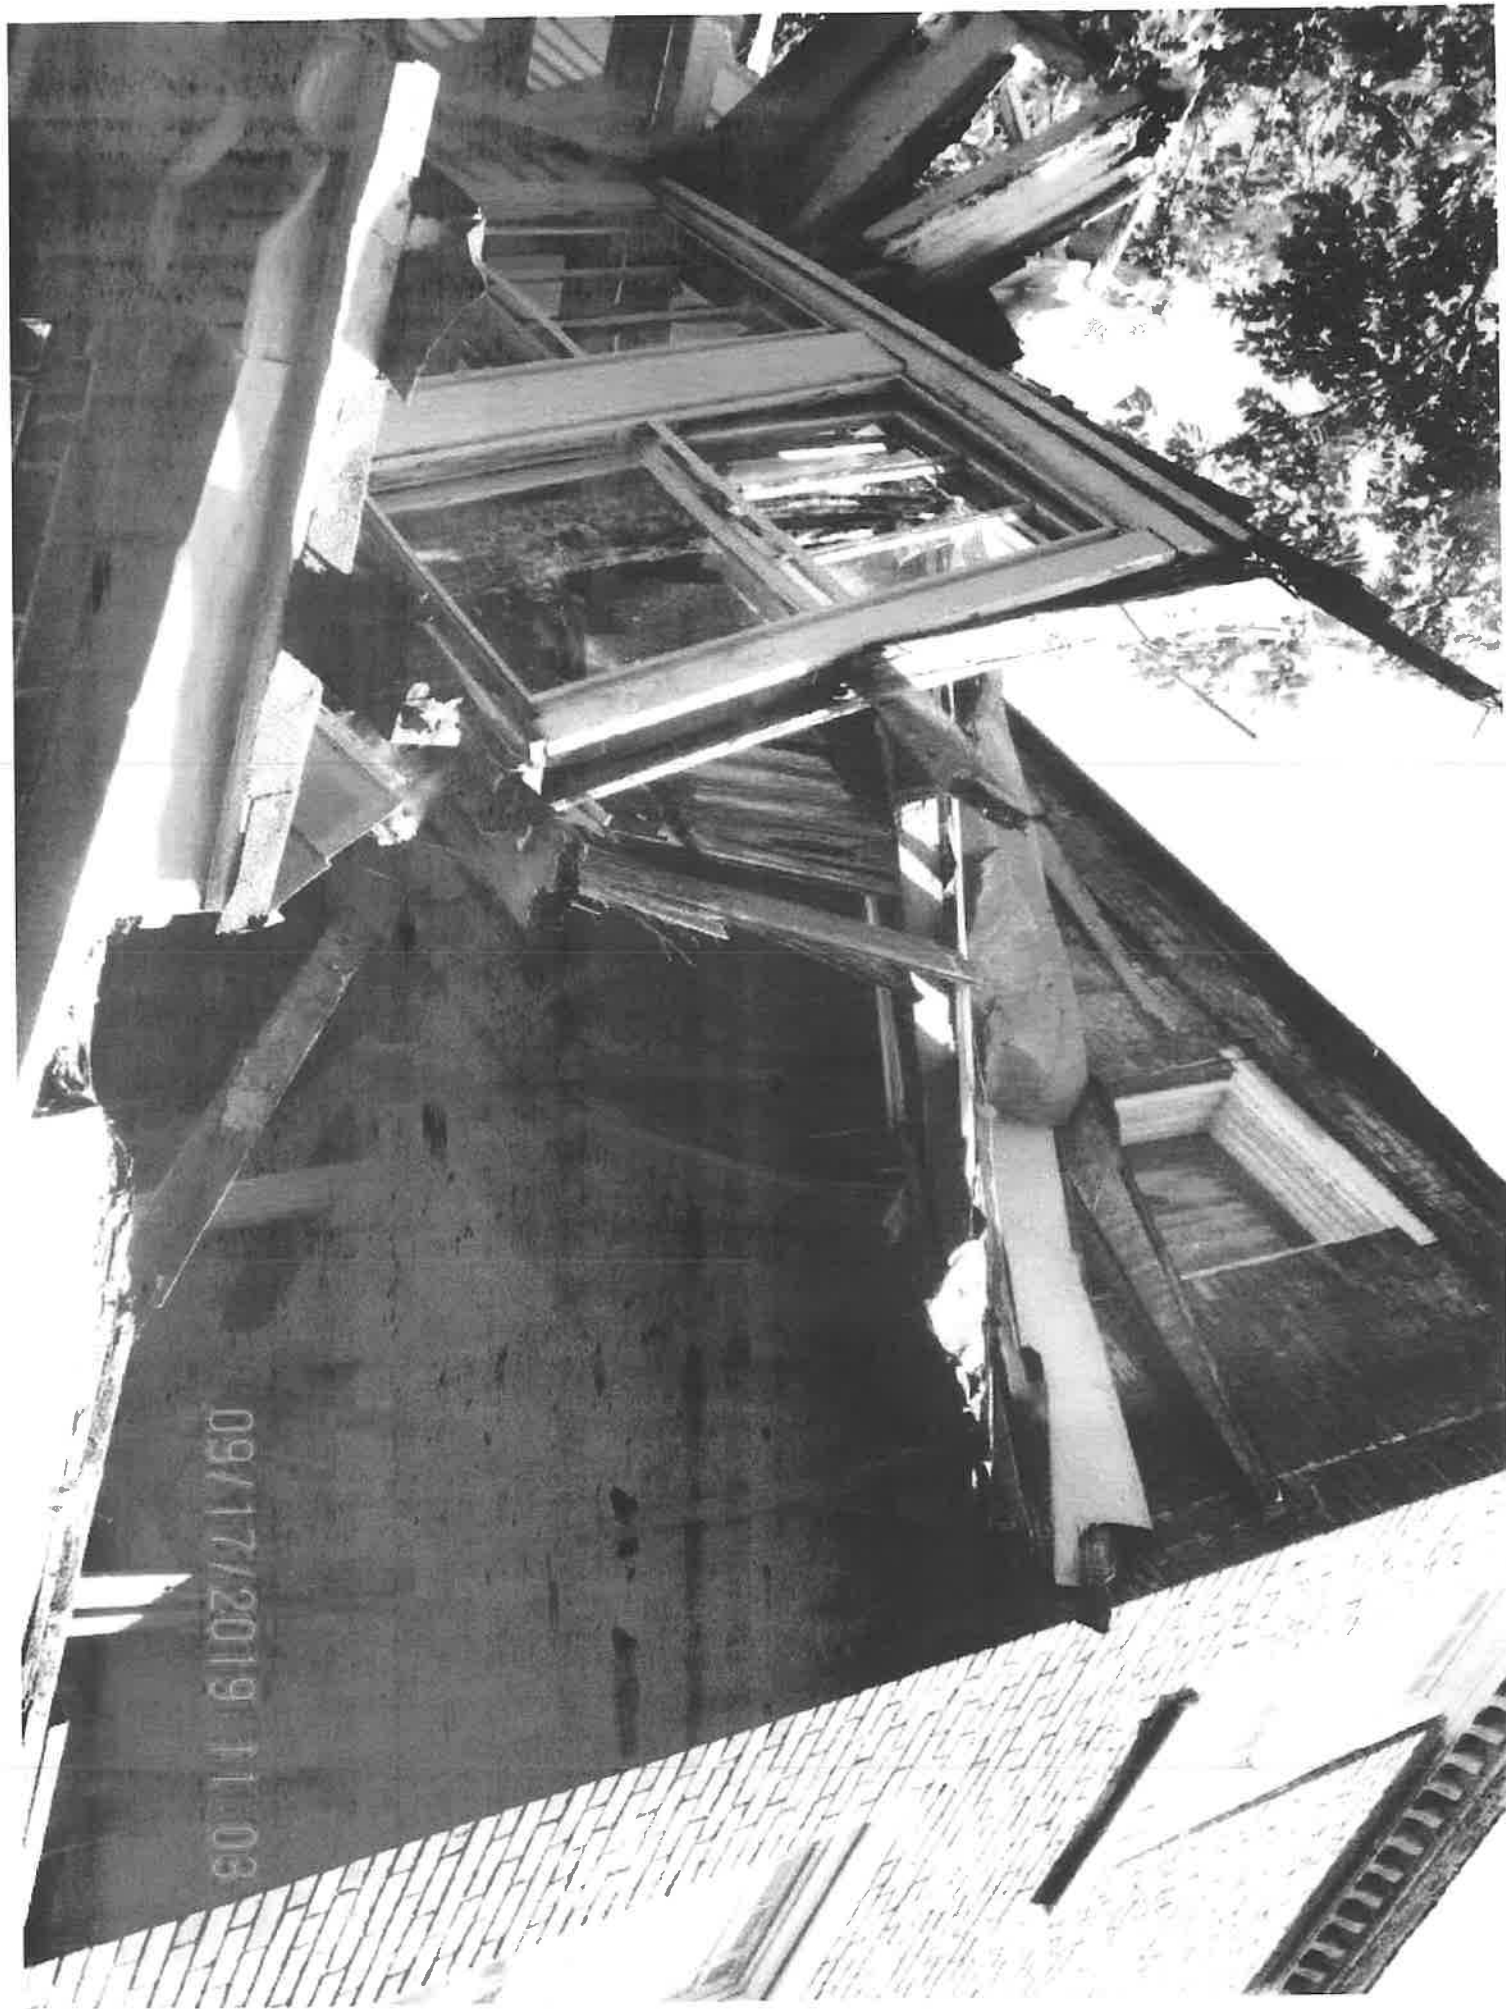
EXHIBIT C

WHEREAS, the Owners failed to comply with the July 19, 2019 Order (see photographs attached as Exhibit “C”); and

WHEREAS, the September 25, 2019 Engineer’s Report notes that ongoing deterioration of the partially collapsed rear block poses a possible hazard to a neighboring property and recommends immediate demolition; and
